Diagnostic Trouble Code (DTC) P0336

58X Crank Position Sensor Extra/Missing Pulses

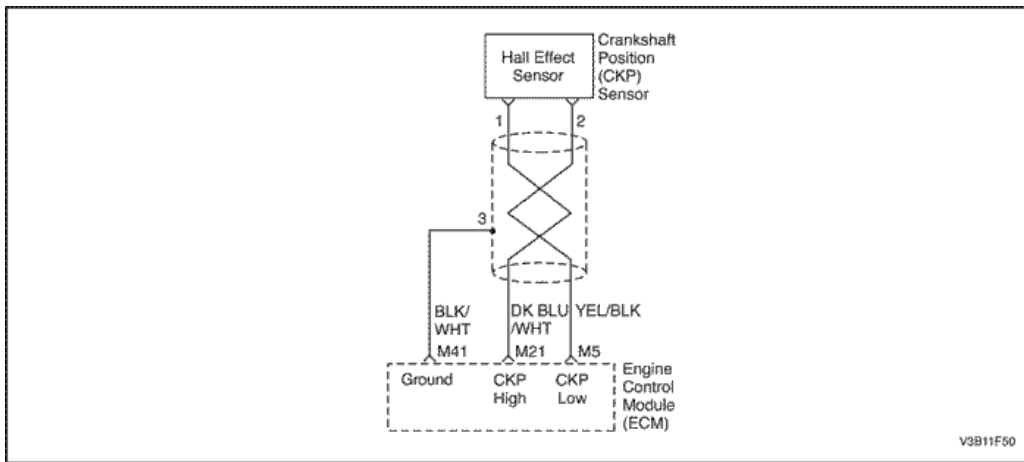
The 58X reference signal is produced by the Crankshaft Position (CKP) sensor. During one crankshaft revolution, 58 crankshaft pulses will be produced. The Engine Control Module (ECM) uses the 58X reference signal to calculate engine rpm and CKP. The ECM constantly monitors the number of pulses on the 58X reference circuit and compares them to the number of Camshaft Position (CMP) signal pulses being received. If the ECM receives an incorrect number of pulses on the 58X reference circuit, Diagnostic Trouble Code (DTC) P0336 will set.

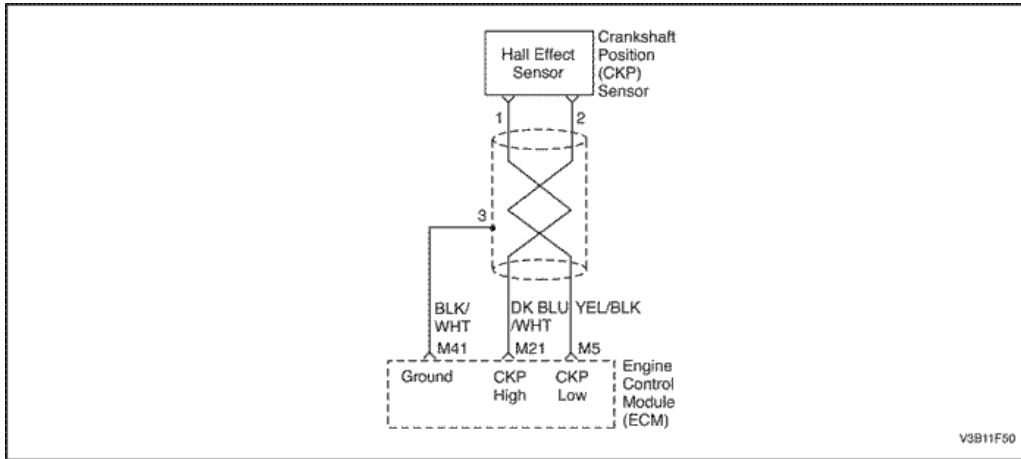
Diagnostic Trouble Code (DTC) P0337

58X Crank Position Sensor No Signal

The 58X reference signal is produced by the Crankshaft Position (CKP) sensor. During one crankshaft revolution, 58 crankshaft pulses will be produced. The Engine Control Module (ECM) uses the 58X reference signal to calculate engine rpm and CKP. The ECM constantly monitors the number of pulses on the 58X reference circuit and compares them to the number of Camshaft Position (CMP) signal pulses being received. If the ECM does not receive any 58X reference pulses on the 58X reference circuit while cranking, Diagnostic Trouble Code (DTC) P0337 will set.
